5/2/11 Baker Risk
Don Ketchum

1 OBSERVATIONS

2 EXPLOSION SCENARIOS CONSIDERED

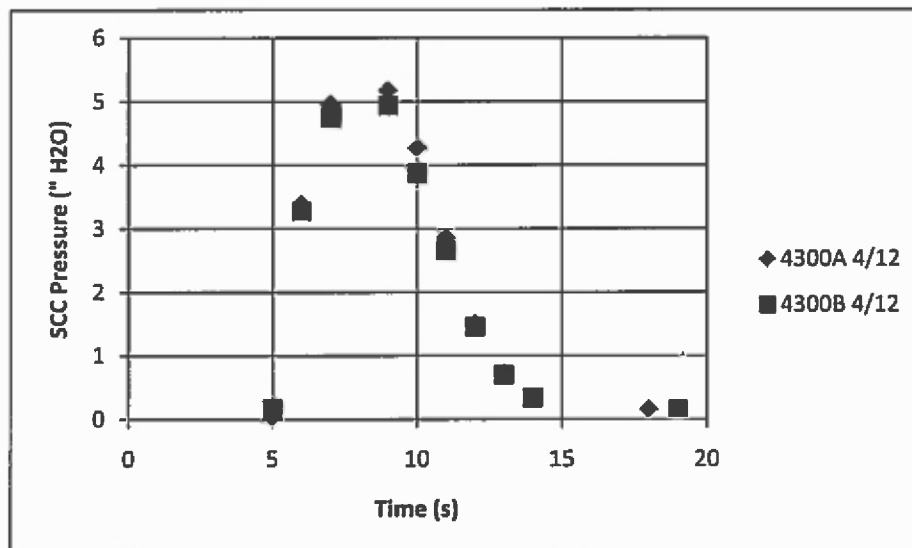
Figure 1. Transient SCC Pressure During 4/12/11 Event

2. The pressure in the SCC build over the course of about three seconds then returns to ambient as shown in Figure 1. This is very similar to the pressure history recorded on December 22, 2010 (see Figure 2).
- 3.

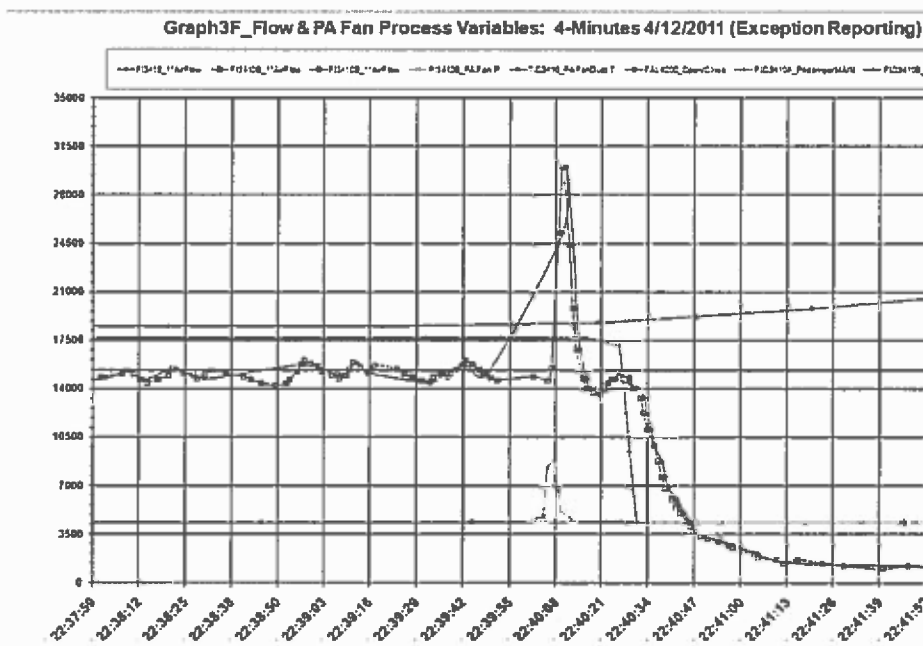
Figure 3. Primary Air Flow Response

| 10 | Failure of combustion air | The primary air flow increases during the event (see Figure 3) |

4. The primary flow from the kiln increased sharply during the incident (FI 3410).

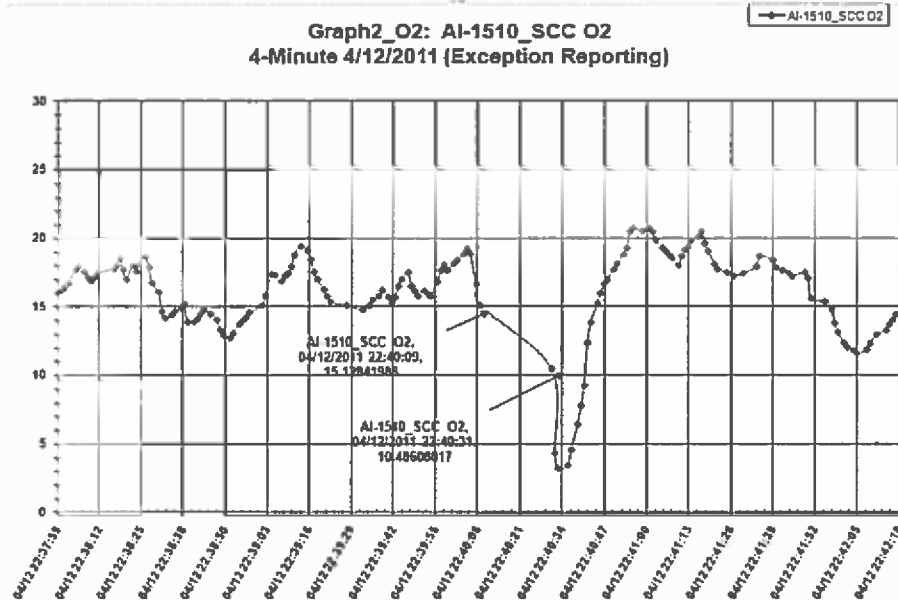
Figure 4. SCC Concentration as a Function of Time

5. The oxygen concentration dropped suddenly in the SCC (as shown in Figure 4), below the 12% needed for combustion.

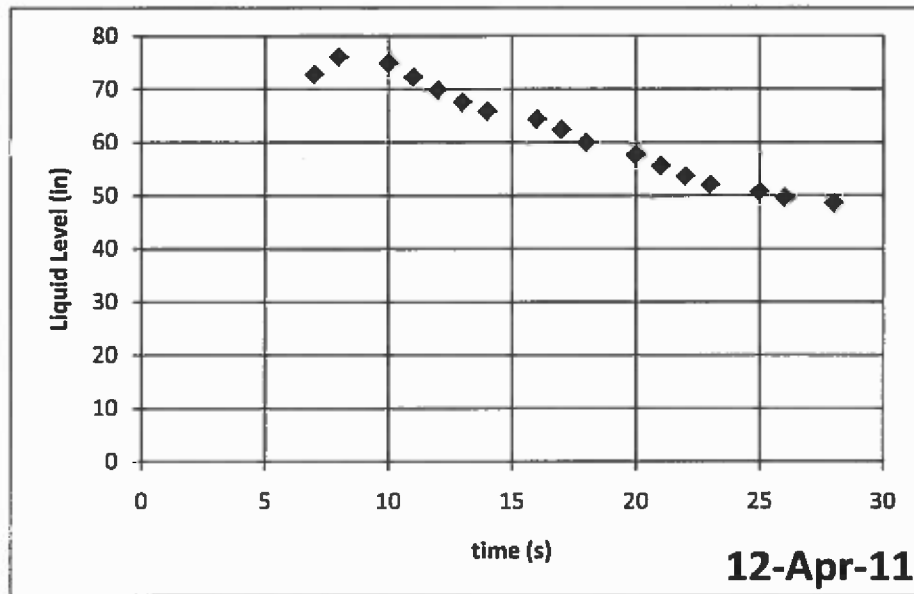
Figure 7. Liquid Level as a Function of Time (Time Zero =22:40:00)

10. The liquid level in the quench pit rises suddenly then falls as shown in Figure 7. This behavior is quite similar to the records of the December 22, 2010 incident and the Jan 16, 2011 incident. A considerable amount of water is lost (vaporized). The liquid level in the pit drops more than 20 inches.
